VERTICAL BARRIER WALL INSTALLATION USING THE VIBRATED BEAM METHOD; AN APPROPRIATE TECHNIQUE IN SELECTED APPLICATIONS

Michael E. Ameel, P.E., Envirocon, Inc., Pittsburgh, Pennsylvania

Kenneth B. Andromalos, P.E., Geo-Solutions, Inc., Pittsburgh, Pennsylvania

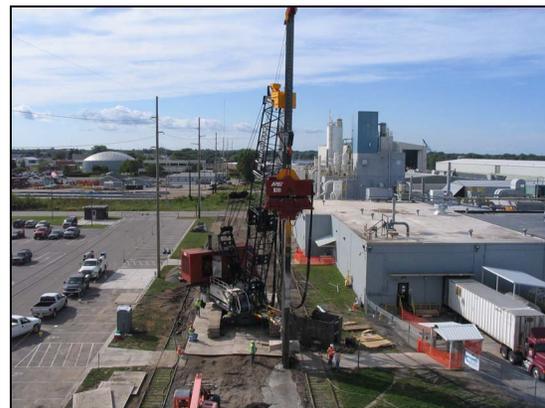
Photo 1 - Overhead view of VBSW operations and proximity to facility structures.

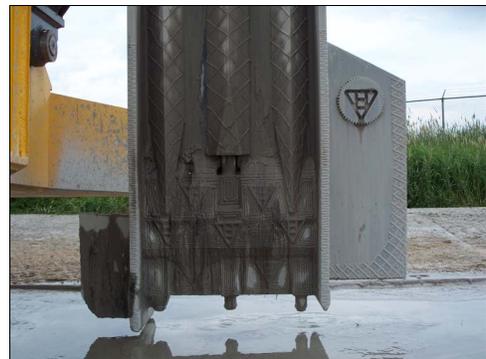
Photo 2 - Close-up of beam tip showing 10-inch fin and injection nozzles.

- Beam - A 50 foot long steel wide flange beam with a web length of 30" and web thickness of 4" was initially used for the project. Because of the effectiveness of the vibratory hammer/beam combination in penetrating the dense glacial till, the Contractor switched to a larger beam with a 36" web thickness for full-scale production. Both beams were equipped with a 10-inch fin on the trailing flange that guided the beam into the previously installed panel to help maintain the beam alignment during installation. The beams were equipped with a steel pipe line and injection nozzle to transport the grout to the tip of the beam (Photo 2).

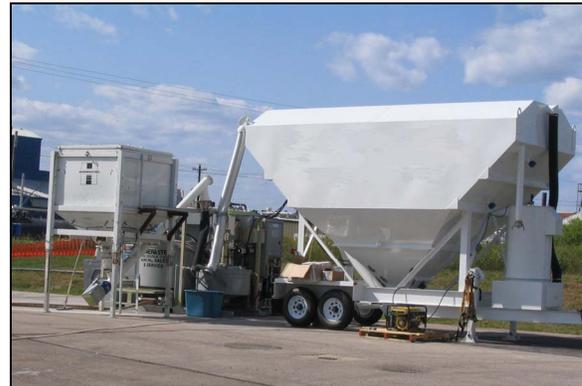
Photo 3 - Automated batch plant and reagent silos.

The slurry for both VBSW and the jet grouting was mixed in batches using the automated batch plant (Photo 3). Initially, a predetermined quantity of water was added to the mixing tank. Based upon the mixing procedure that was used during the bench-scale testing, the powdered clay was added to the pre-measured volume of water and mixed for approximately 60 seconds; the cement slag was then added to the water/powdered clay mixture and the combined

Both the powdered clay and slag cement were added to the mixing tank via an auger feed. A small 'super bag' feed silo, which was equipped with an auger feed, was used to add the powdered clay to the mixer. A 'super bag' of powdered clay was placed on top of the small bag feed silo. The 'super bag' was equipped with a draw string that when removed allowed the material to flow into the smaller silo. The auger feed for the slag cement was mounted directly on the 30 ton silo.

The batch plant was equipped with a flow meter to measure water, and also incorporated an integral scale to weigh the dry materials. The batch plant was programmed to add the three materials (i.e., water, powdered clay and blast furnace slag) to the mixer in the proportions according the bench-scale mix design study. Once a batch of slurry was sufficiently mixed, the slurry was transferred from the mix tank to the reservoir tank. Another batch of slurry was then mixed in the mix tank, transferred to the reservoir tank and the process repeated.

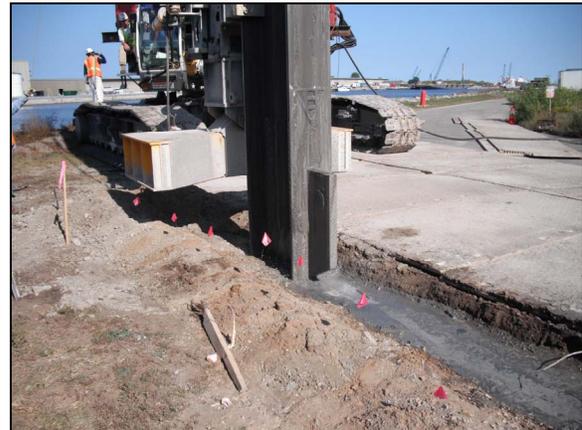
Photo 4 - Excavated trench used to contain excess slurry.

- Along the VBSW alignment, a shallow pre-trench was incorporated into the crane platform to contain the excess grout slurry (spoils) as they came to the surface (Photo 4). Spoils from the pre-trench were managed and removed as needed. If, necessary, at the beginning of each production day, additional grout was placed in the trench to replace any grout slurry that may have been lost due to settlement.

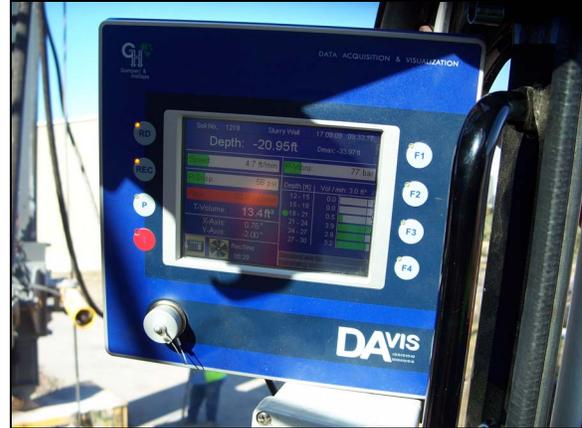
Photo 5 - Data acquisition system display mounted in cab of crane.

The crane used for the VBSW installation was equipped with a data acquisition system to collect and record quality control data during the VBSW installation. The Contractor utilized equipment manufactured by Gamperl & Hatlapa (G&H). For each VBSW panel the crane operator entered the Panel number into the G&H system (Photo 5). As the panel was installed, the G&H system collected and recorded the verticality of the beam, the start time of the panel insertion and end time for the withdrawal, the total panel length, the total volume of grout injected during the insertion and withdrawal cycle, and the volume of grout injected only during the withdrawal cycle. On a daily basis, the G&H system also recorded the sum of the length of VBSW panels installed, the total volume of grout injected during the insertion and withdrawal cycles, and the volume of grout injected during only the withdrawal cycle.

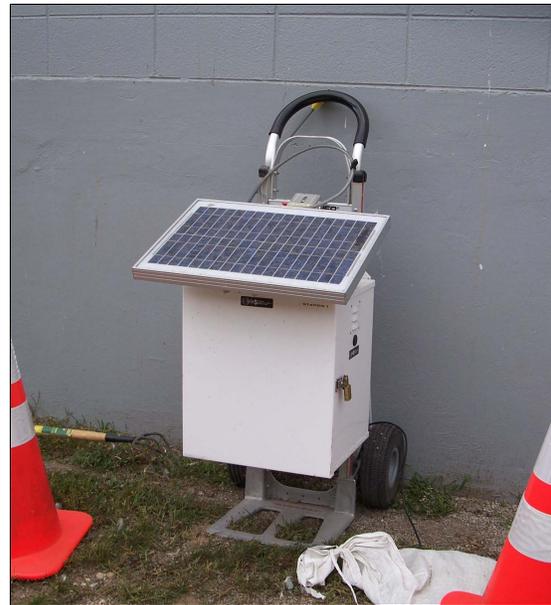
Photo 6 - Portable vibration monitors.

The Contractor utilized two InstanTel Minimate Plus portable vibration monitors (Photo 6) to measure the ground vibration as particle velocity in accordance with the Project Specifications. Each of the vibration monitors was equipped with wireless cellular modems that transmitted and downloaded the vibration data to the seismic survey subcontractor's office on a daily basis. As specified, the monitors measured and recorded particle velocity in three directions. The maximum specified allowable peak particle velocity limit was one inch per second (1 in/sec) as measured in either one of the three directions or as the sum of the three velocity vectors.

As the VBSW installation progressed, the two monitors were moved and placed proximate to structures, utilities, or other potentially sensitive objects. Typically, one monitor was placed proximate to the VBSW operations and the second would be placed along the VBSW alignment ahead of the VBSW operations. The locations of the two monitors were recorded in the Contractor's Daily Report. During the vibration monitoring period, pre-determined particle velocity trigger levels were set in each monitor such that if the particle velocity trigger levels were exceeded, the wireless cellular modems within the monitors would send an electronic mail message to notify the Contractor's personnel of the exceedance. The individual velocity triggers were set at 0.02 in/sec, which were far below the maximum specified allowable value.
